Load Testing of Timber Hardwood Bridge Beams

Low Volume Roads Conference
Christchurch July 2003

Paper submitted by: John Laskewitz, Local Government and Transportation Group Manager & Chris Thomas, Graduate Civil Engineer, MWH Invercargill

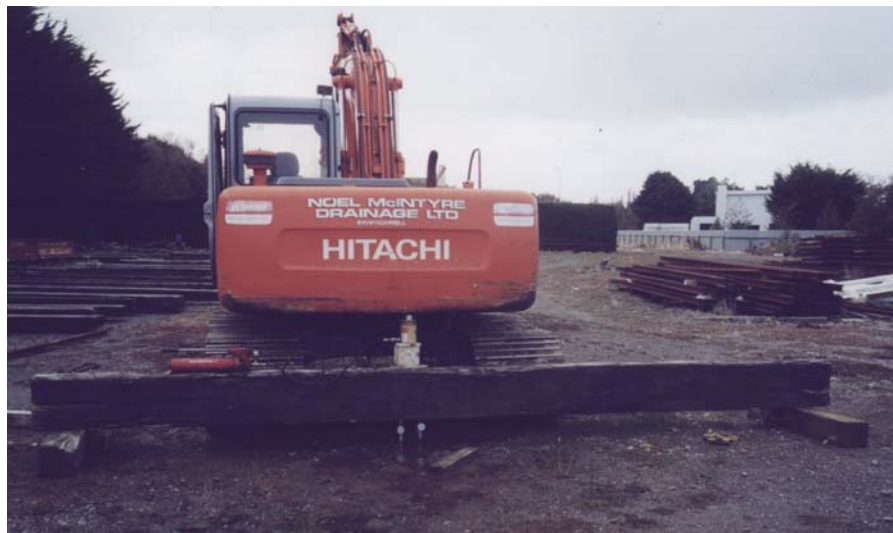
Figure 1. Beam test setup

The beam to be tested was then placed on timber packers at each end and a deflection gauge was placed underneath the point of application of the load (the midpoint of the beam) and also at each end of the beam. The packers were spaced at 5400mm from centre to centre for each of the beam tests. A hydraulic jack was placed on top of the beam and a 20 tonne excavator was used as the counterweight to jack against.

The bucket of the digger was placed on the ground in front of the tracks to prevent rotation of the excavator in the event that it was easier to lift the digger than bend the beam. The counterweight placed no direct weight on the beam. The test set up is shown in figure 1 below. (Note that the beam obscures the deflection gauges at the two ends.)

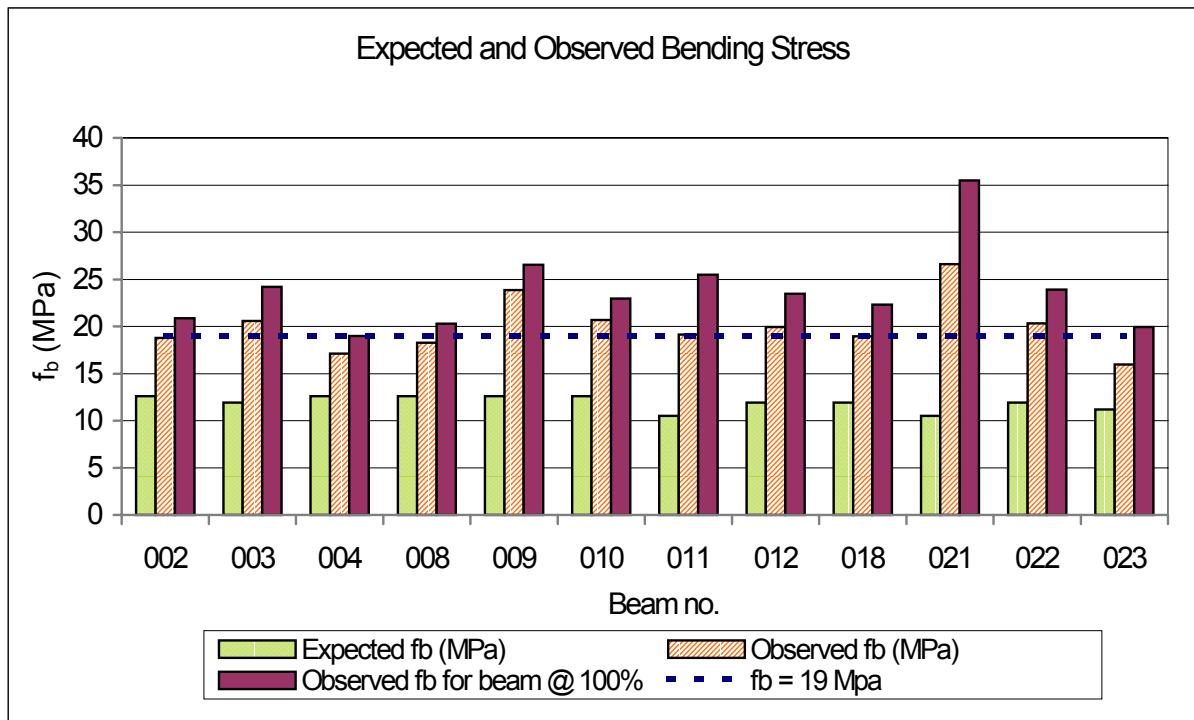
Figure 4. Expected and observed bending strengths

During the testing of the beams, bending strengths ranging from 16 MPa to 26 MPa were observed within the constraints of the equipment available. These values are shown in figure 4 below as well as the expected value for the bending strength. The expected value for the beam is its condition rating multiplied by $f_b = 14$ MPa which has been used for posting calculations previously. A column showing the observed bending strength divided by the beam rating is also shown (Observed f_b for beam @ 100%). This relates the bending strength back to the value that would be used in calculations.

The value of 19 MPa is shown as a dashed line in figure 4 above. It can be seen that all of the adjusted observed results are at least equal to this value and this is suggested as a suitable value for bridge posting purposes in the Southland District.
