# Performance of Foam Bitumen Stabilisation in the Wakatipu

August 2011

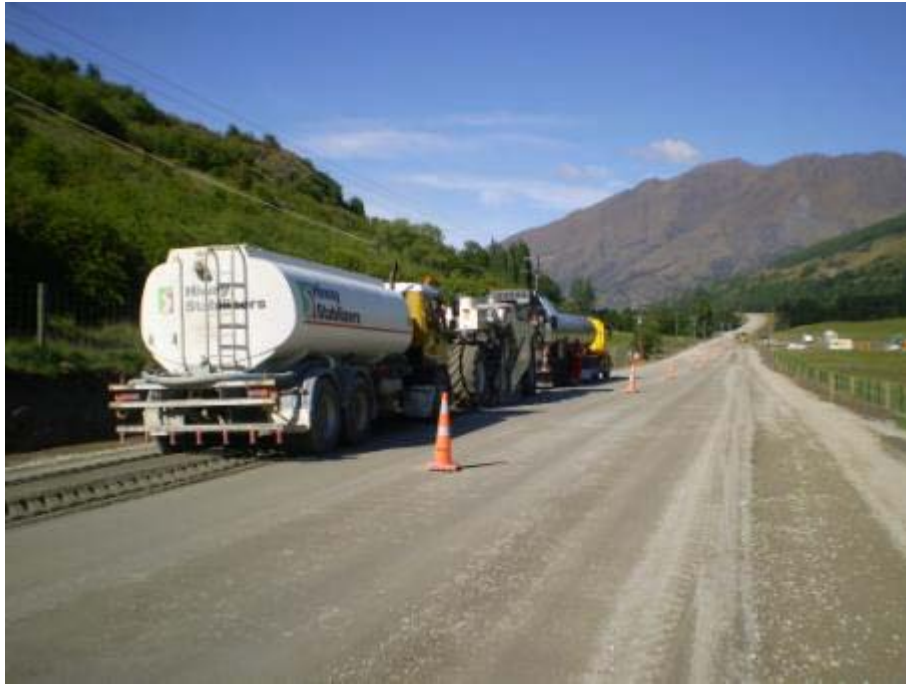
Malaghans Road Site 1 Rehabilitation and Widening 2009-10.

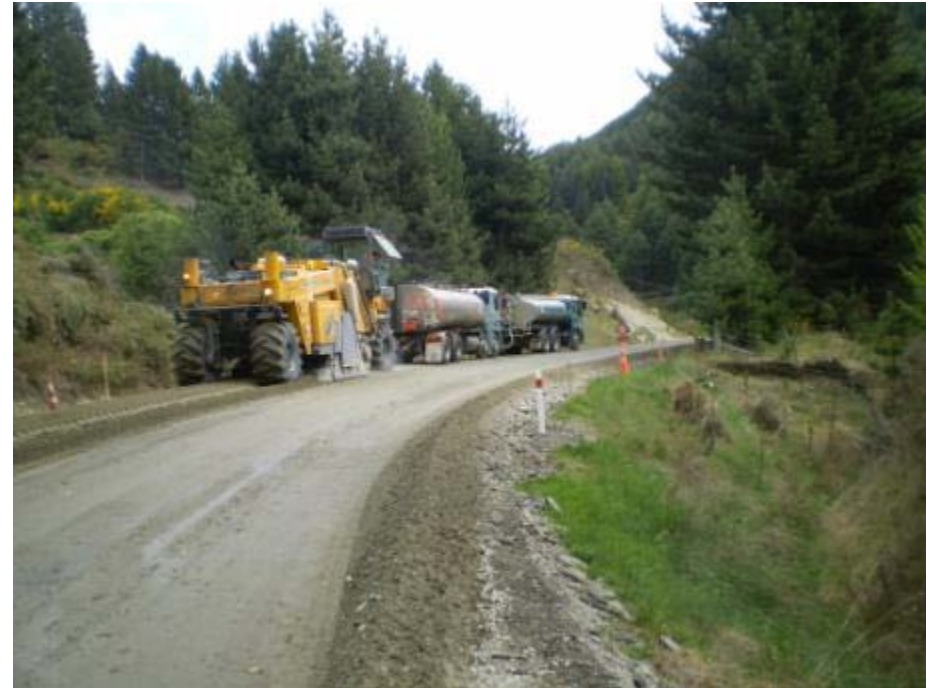
Glenorchy Road Pavement Rehabilitations 2009-10

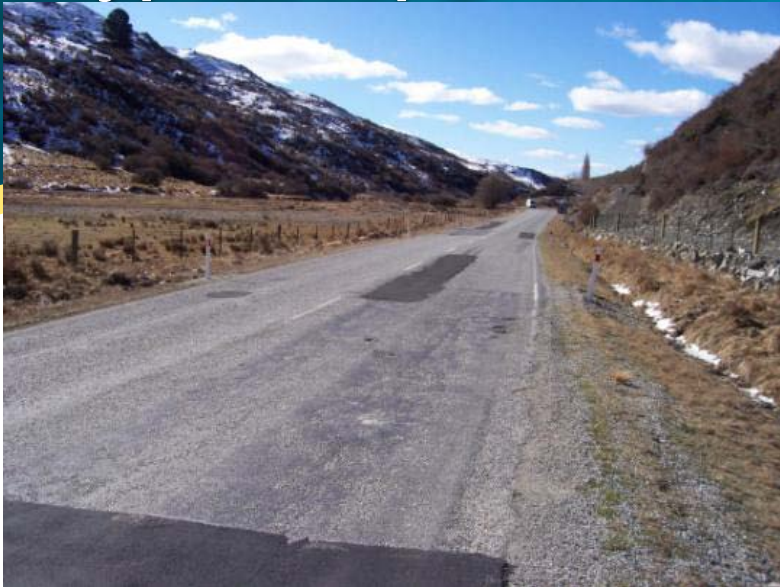
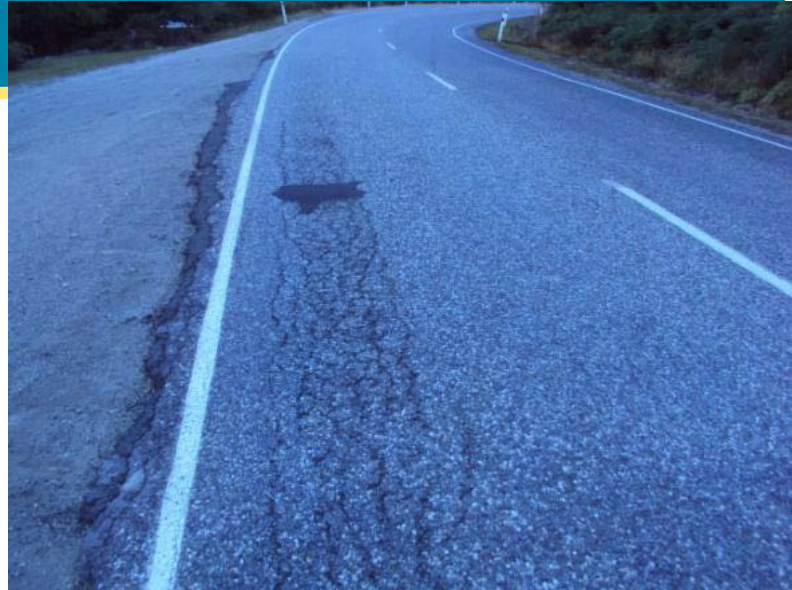
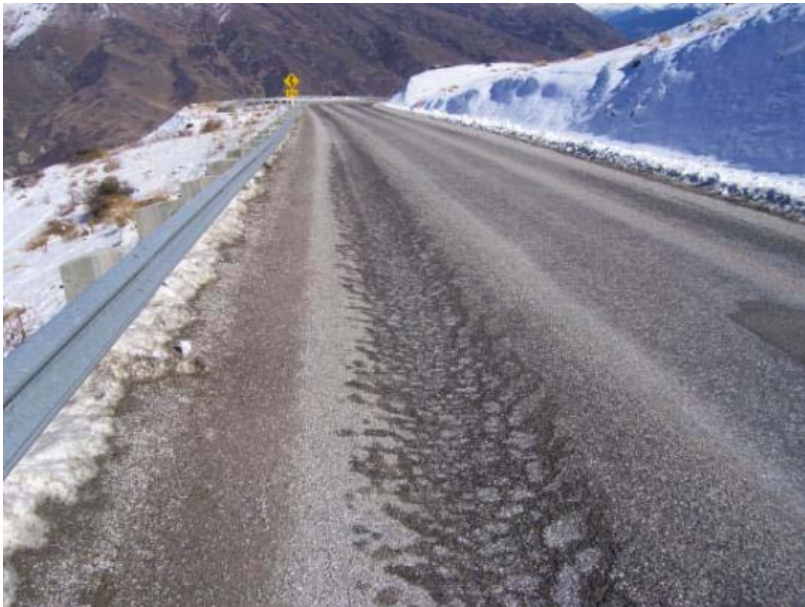
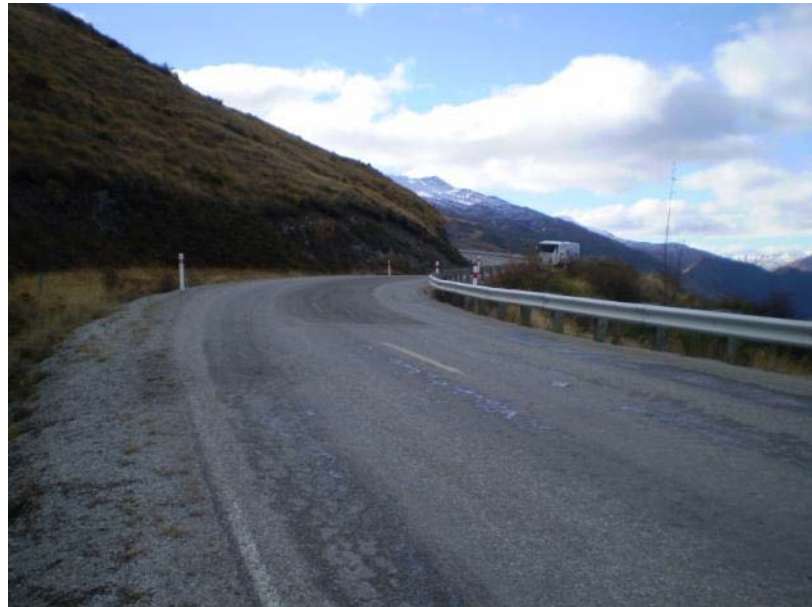
# Types of pavement failures we are treating

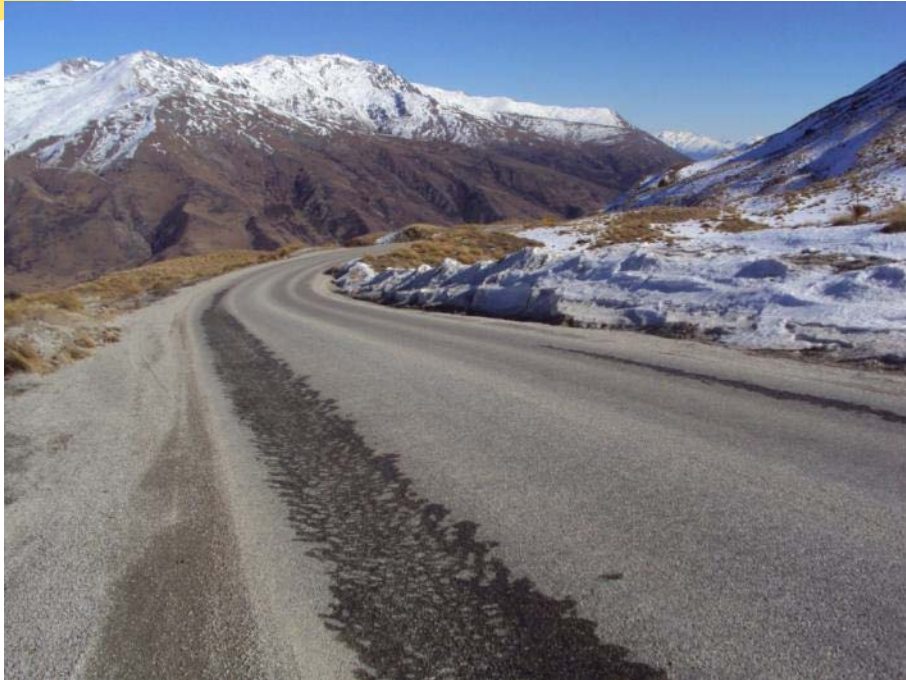
Ongoing Crown Range Road Rehabilitation and many other rural arterial sites.

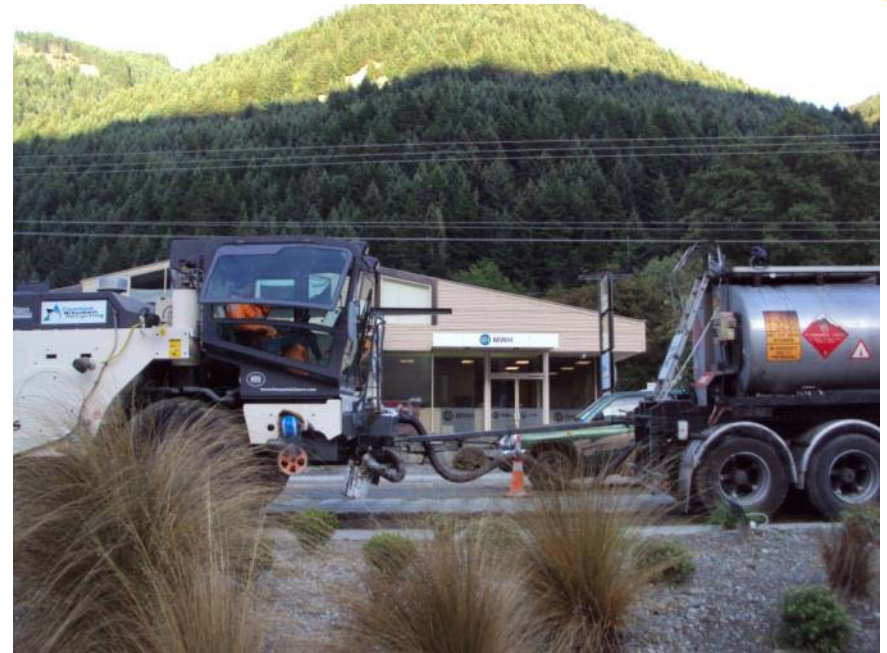
Increasing Urban use – Gorge Road 2010/11 Pavement Rehabilitation

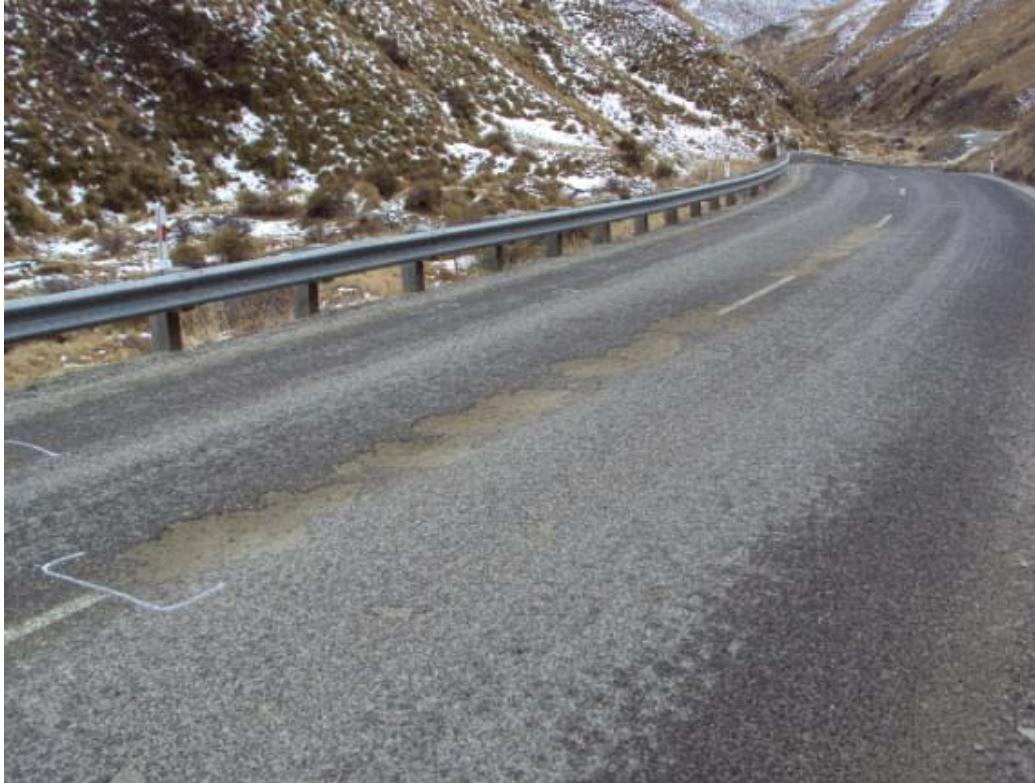
First coat sealing on Crown Range Road in 2009-10 season encountered significant seal failures during winter. Pavement was remarkably intact after stripping of surfacing and exposure to moisture and traffic. Testament to the success of the stabilisation of the pavement as a granular pavement with a failing seal in this environment would rapidly fail.

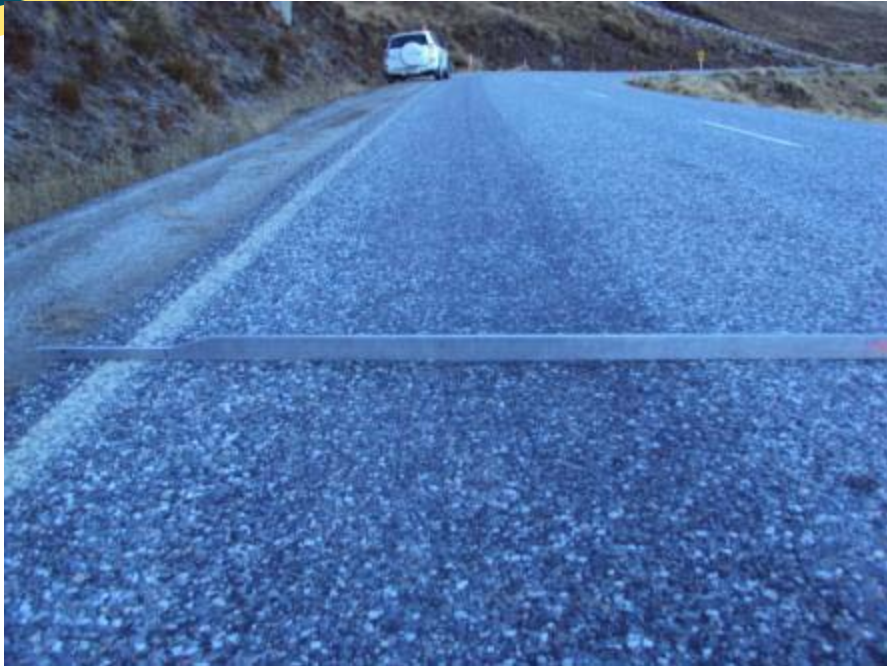
The worst ruts I could find on Coronet Peak Road, <10mm.

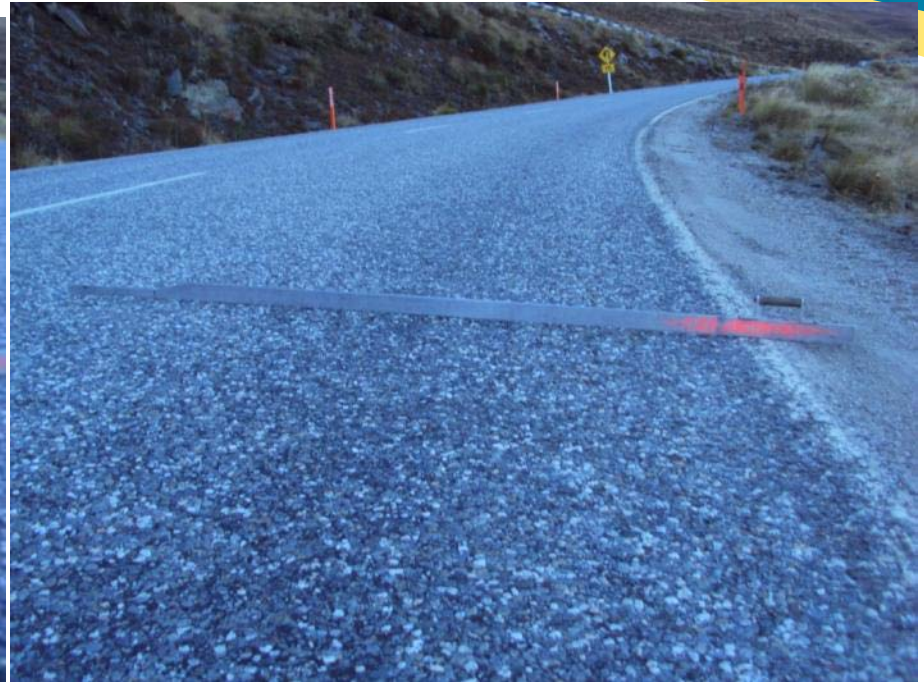
Will these ruts continue to progress to alligator cracking and potholing?

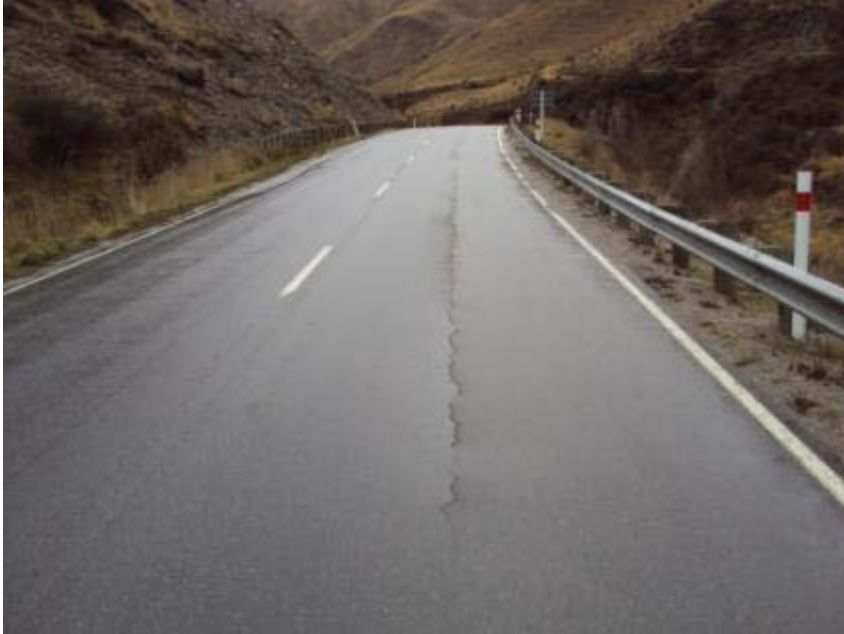
Longitudinal Cracking in Asphalt on Crown Range FBS site.

Land movement or lateral expansion??

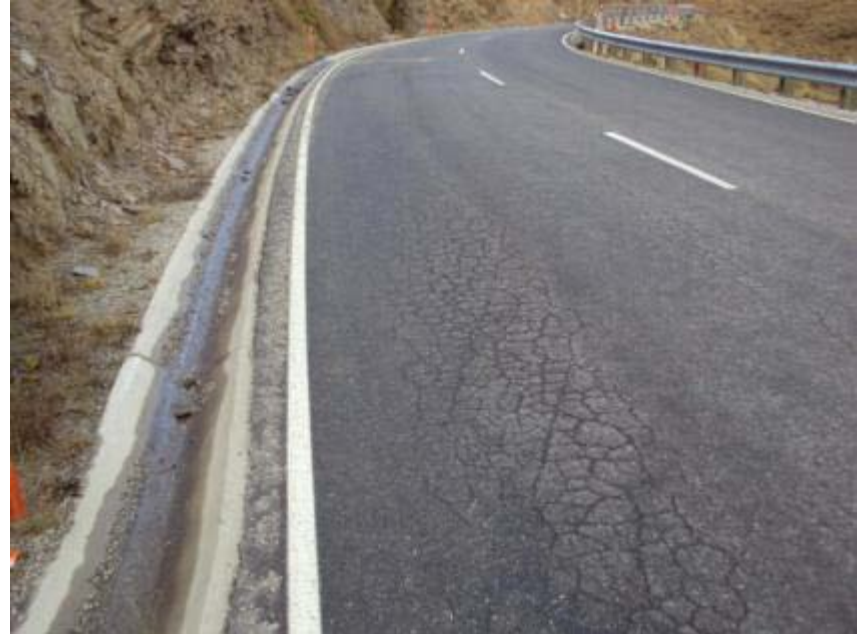
Isolated alligator cracking of asphalt on Crown range FBS site.

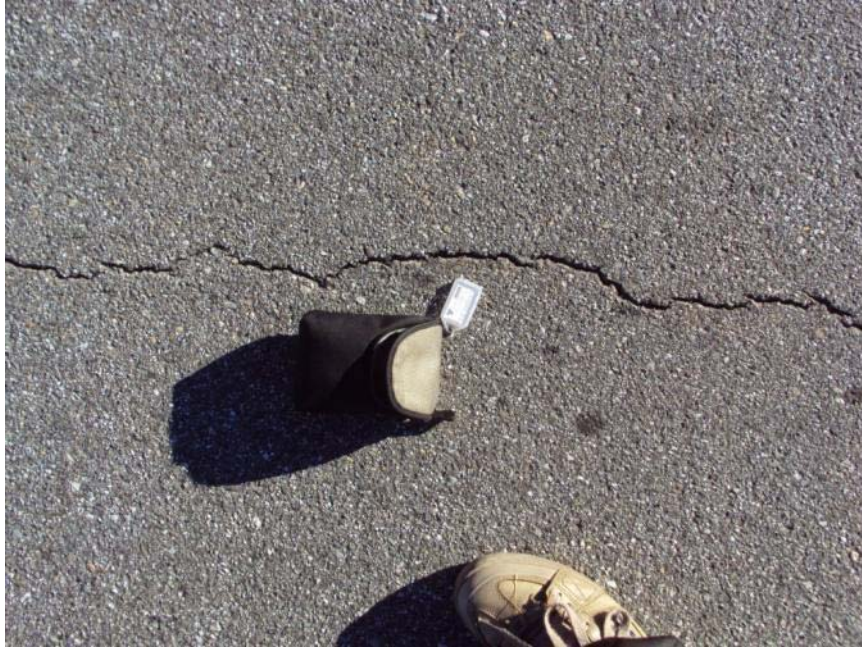
Significant longitudinal cracking. How do we mitigate this?

Crack sealing since applied as proactive maintenance.

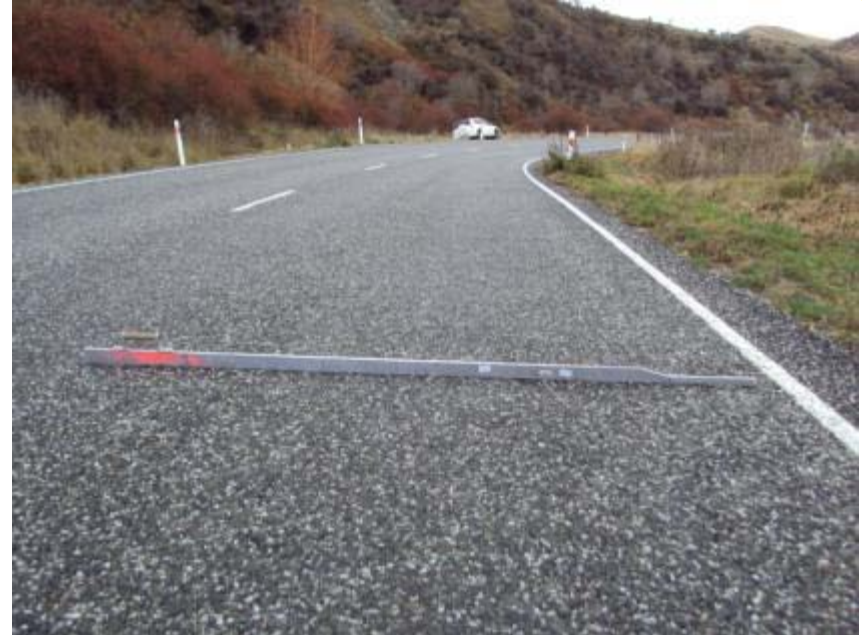
FBS and chip seal site from 2007/08 no sign of rutting at all.

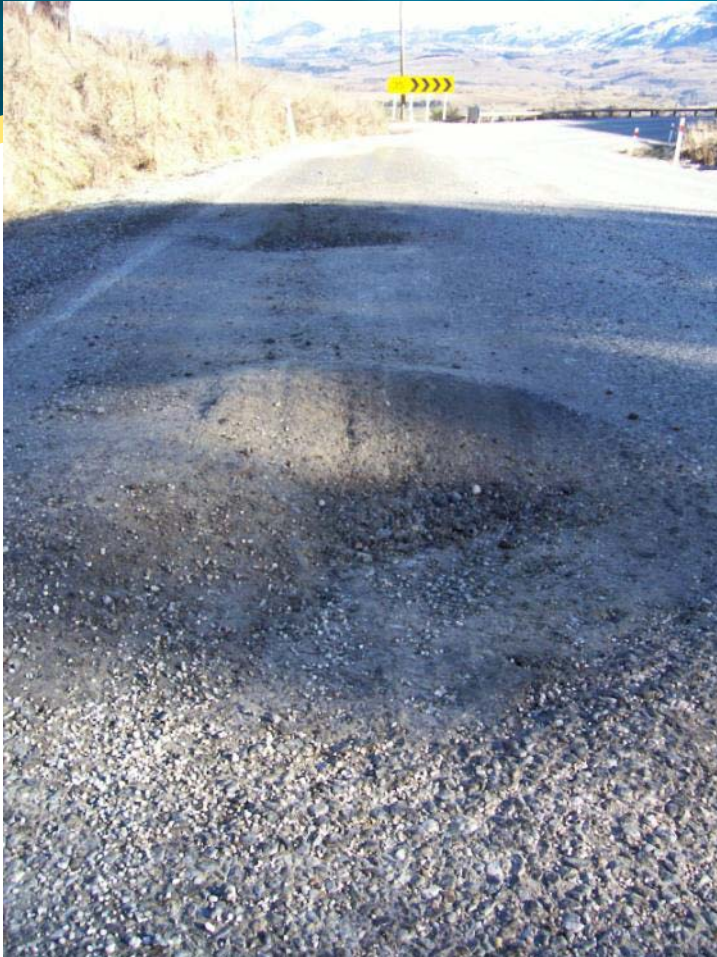
- Plastic shear/shoving failure on saturated section of Royalburn project.

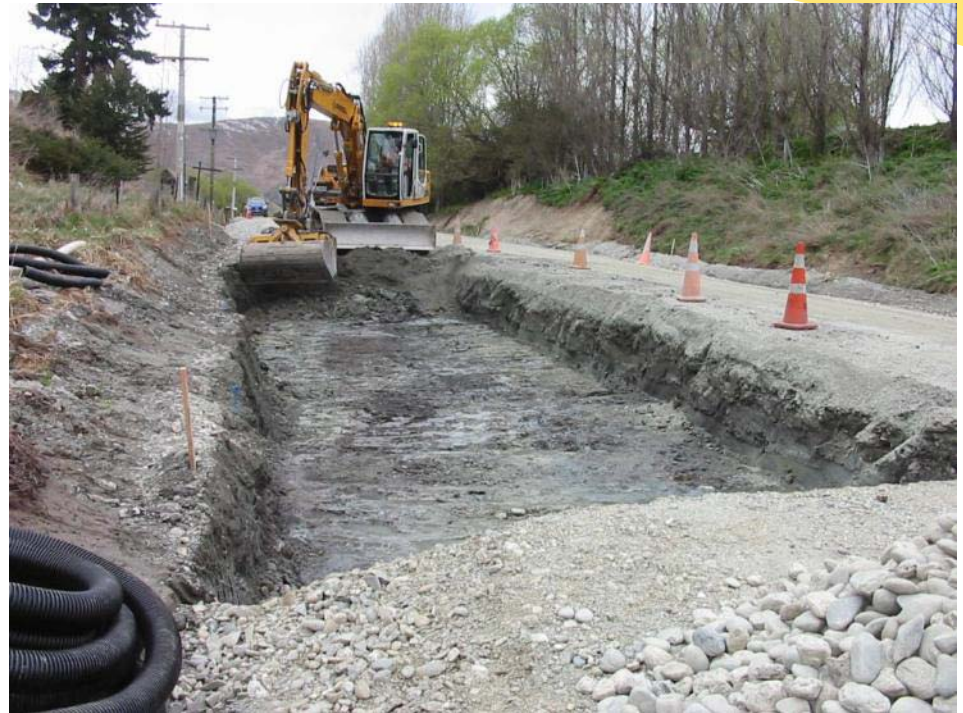
- Deep undercut and subsoil drainage installed in opposite lane during rehabilitation project. However the water found a way!

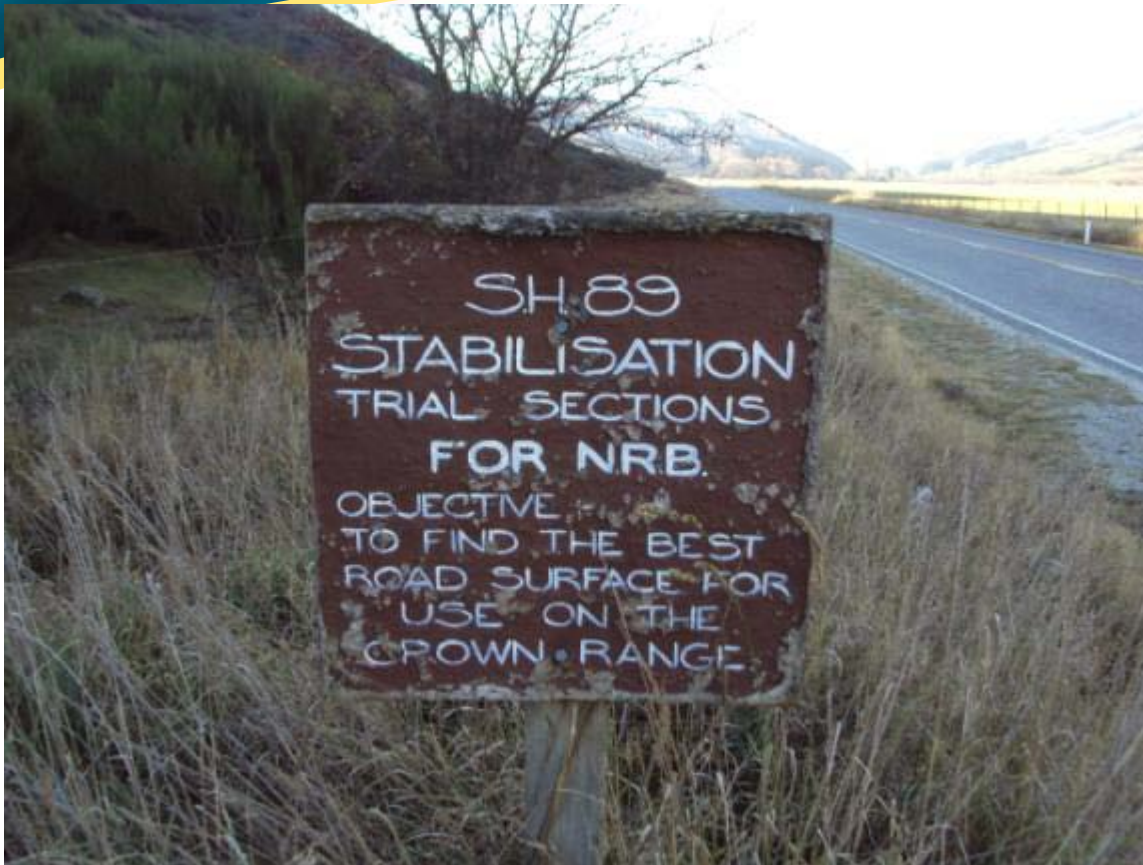
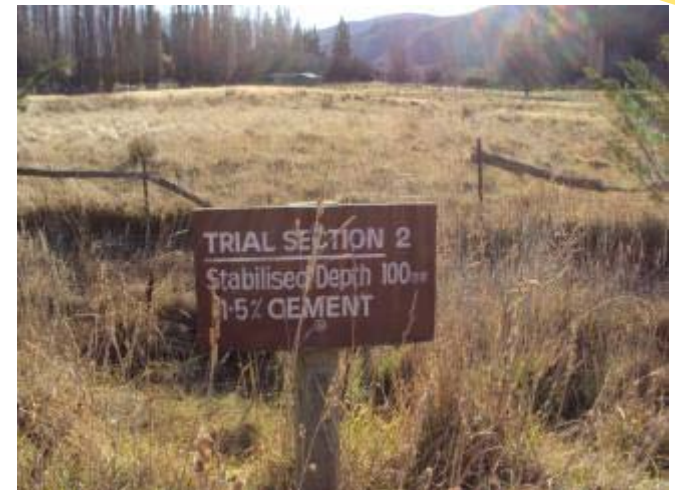
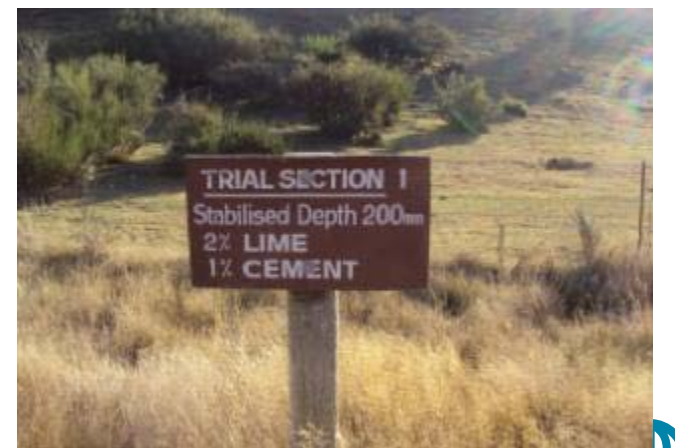
Stabilisation trial sites in Cardrona Valley from early 1990's and original trial data could form very useful resource for consideration of alternative treatments.
